18th April, 2007

RE: PAVILION BUILDING - ST MARYS RECREATION GROUND

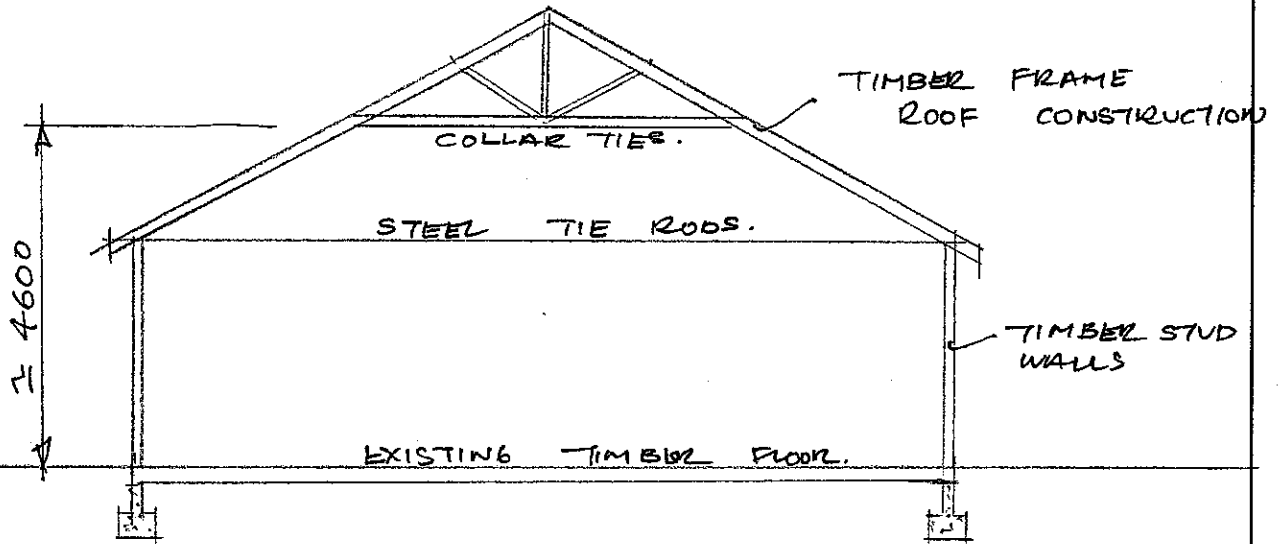
EXISTING CROSS SECTION

- Roof framing consists of 125 x 50mm hard wood rafters @ 600 crs with collar ties. However the rafters have bent at the collar tie location and steel tie rods have been placed at wall top plate level in 6 locations along the building. This is not very satisfactory
- There is no ceiling and infact the existing structure will not support a ceiling
- Roof bracing is not sufficient. It does not comply with today's Wind Code. Roof bracing is being provided by the corrugated iron cladding
- Walls are of timber stud construction and clad on the outside with vertical hardwood boards in fair condition. Internal linings are hard board. There is no way of checking the extent of any wall bracing without removing all the internal linings
